## MEMORANDUM

Date: June 29, 2021  
Client: East Norriton Township  
Project Number: PMENT027  
Re: 2921 Hannah Avenue Drainage

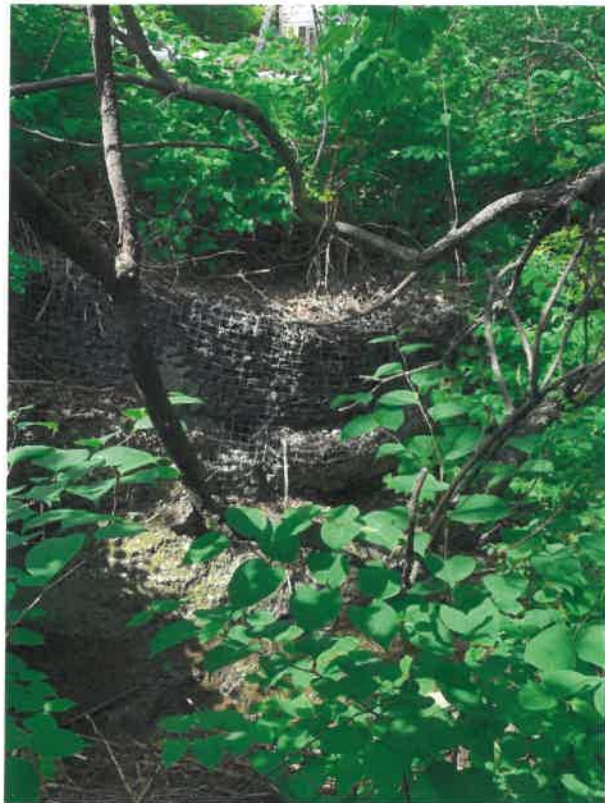
- The existing gabion wall is starting to buckle and deform. Given time it appears that this wall will eventually continue to deform and will eventually collapse and fail. (Figure 2 & 3)
- The portion of gabion wall above the 42" concrete pipe that outlets to the stream at this location is also beginning to buckle and deform. (Figure 4)
- The concrete culvert wall that abuts the 42" concrete pipe and gabion wall above it has shifted. Erosion has occurred beneath this wall and there is approximately a 1' gap from the bottom of the wall to the ground along one side of the wall. The wall is leaning in that direction and is also slightly leaning from the top and may eventually topple over. (Figure 5 & 6)
- It appears that a concrete floor was attached to the culvert but has broken off. (Figure 7)

Figure 2 – Gabion Wall

RVE recommends that the culvert headwall be replaced. Rip rap shall be installed to prevent further erosion at the toe. A stabilization mattress shall be installed along the swale's embankment to prevent further erosion. The approximate total project cost estimate is \$100,840.63.

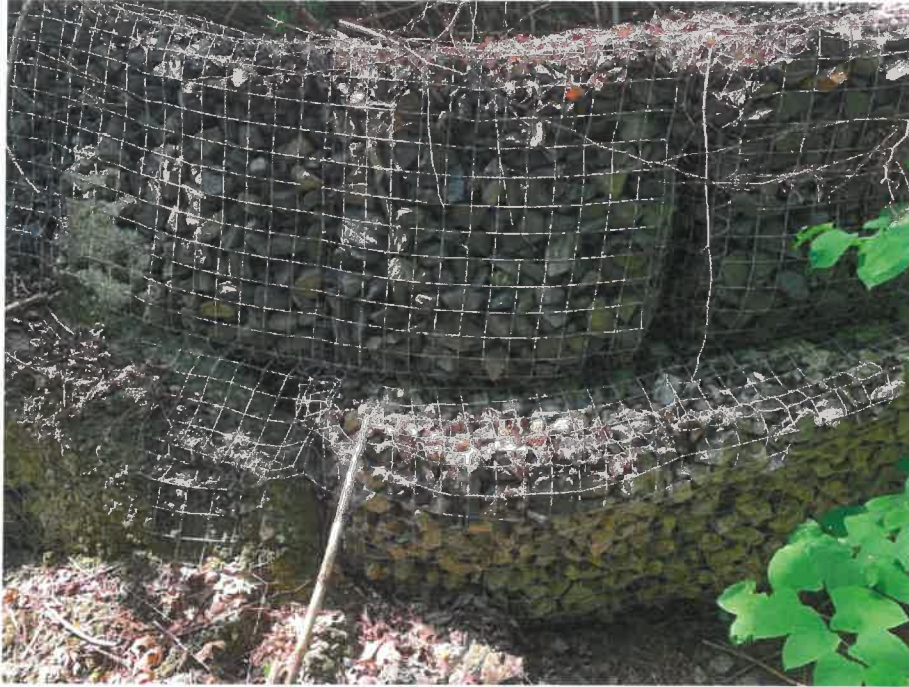
Figure 3 – Gabion Wall Closeup

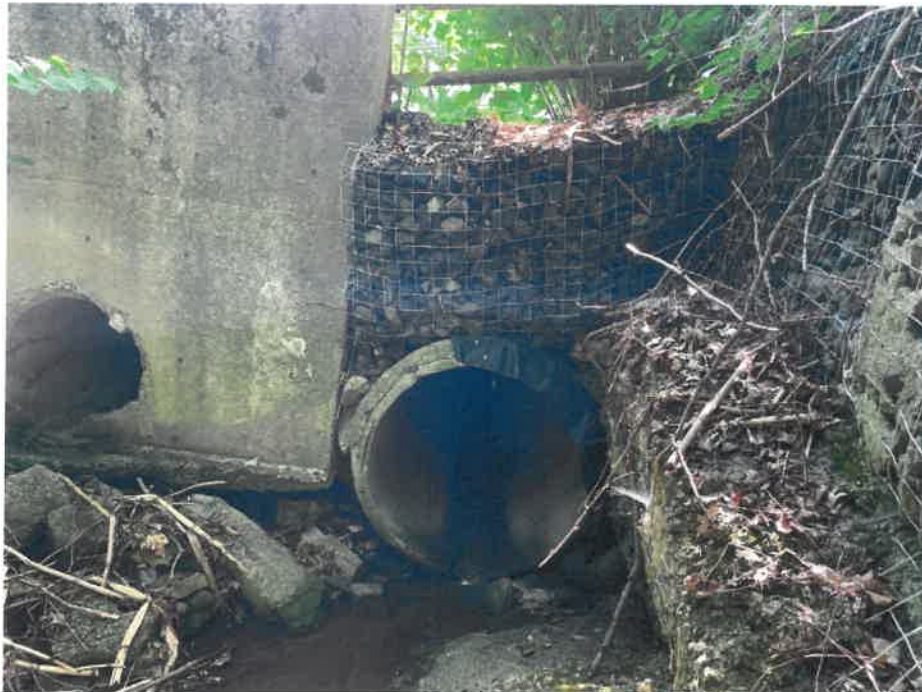
Figure 4 – Concrete Outlet Pipe

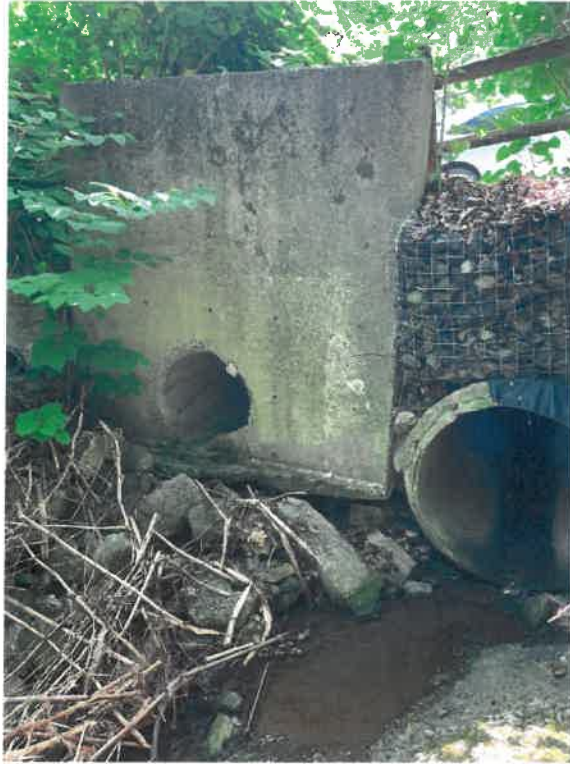
Figure 5 – Concrete Culvert Wall

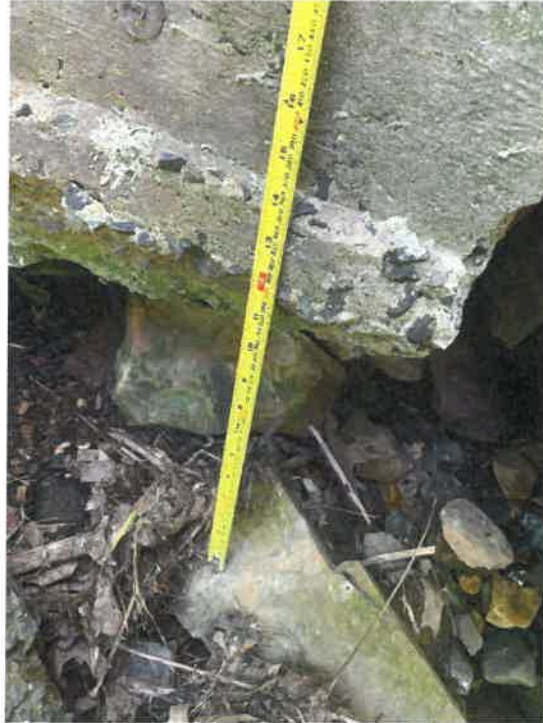
Figure 6 – Erosion at Culvert Wall

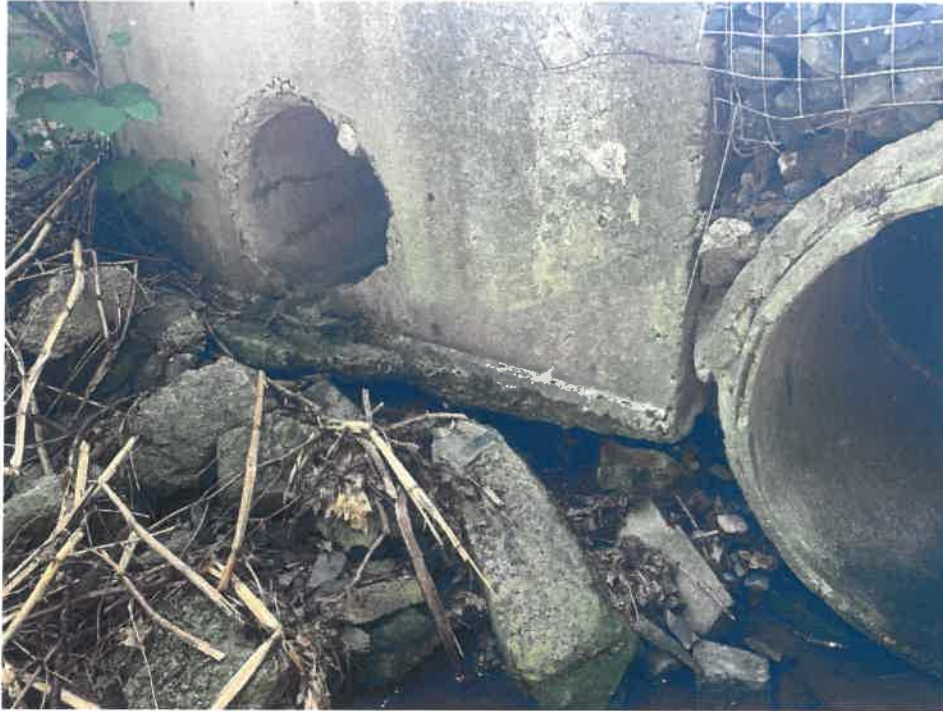
Figure 7 – Broken Concrete Floor
